Fire, Water and Load Tests on  
Berger's *Metal Lumber* System  
(Patented)

Pressed Steel Fireproof Construction

## Test No. 1. (Unofficial)

## Test No. 2. (Official)

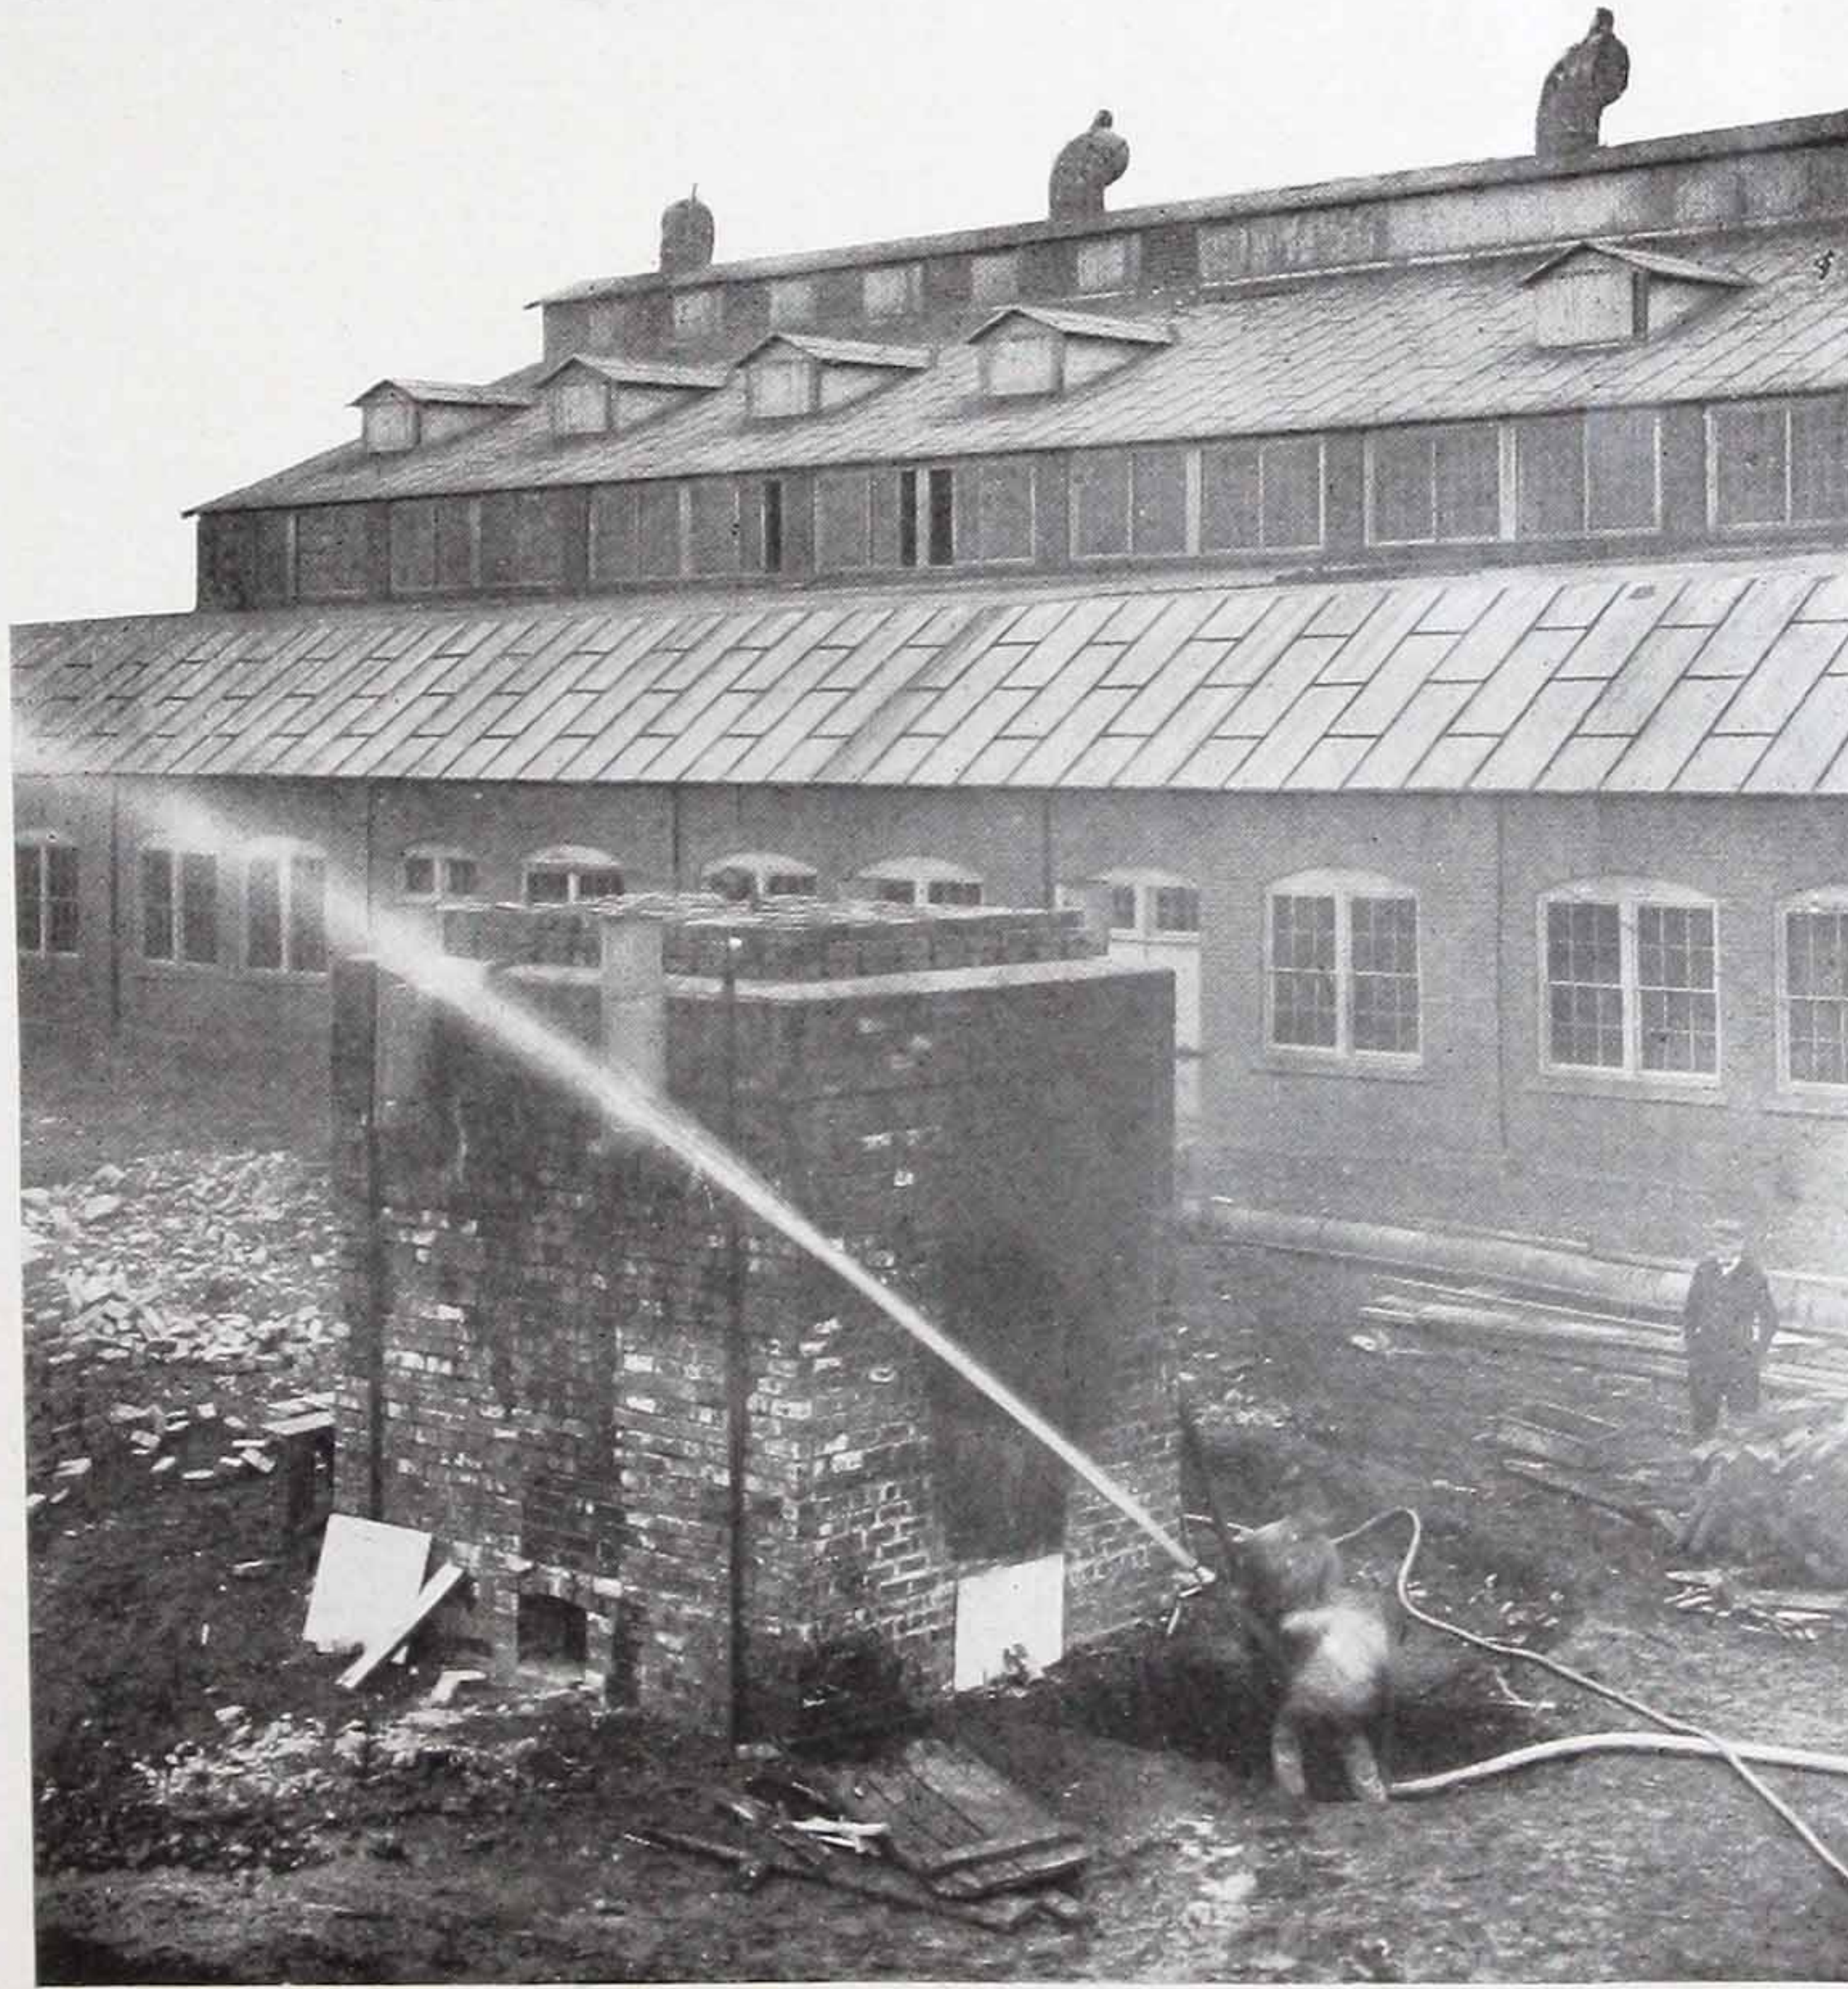
Fire, Load and Water Test on METAL LUMBER System of Fireproof Floor Construction. Temperature 2408° F. Note Water Pressure, 65 lbs. per Square Inch at Hydrant. 1⅛-inch Diameter Nozzle.

Where the stream of water was applied to the ceiling and allowed to be directed at one spot for a considerable length of time, the plaster was removed, exposing an area of approximately 2 square feet of Expanded Metal Lath. At other points of the ceiling

where it was applied at frequent intervals the second coat of plaster fell off in some cases; but the scratch coat remained wholly intact with the lath completely encased, and on only about one-third of the furnace was the plaster removed at all. In the other two-thirds

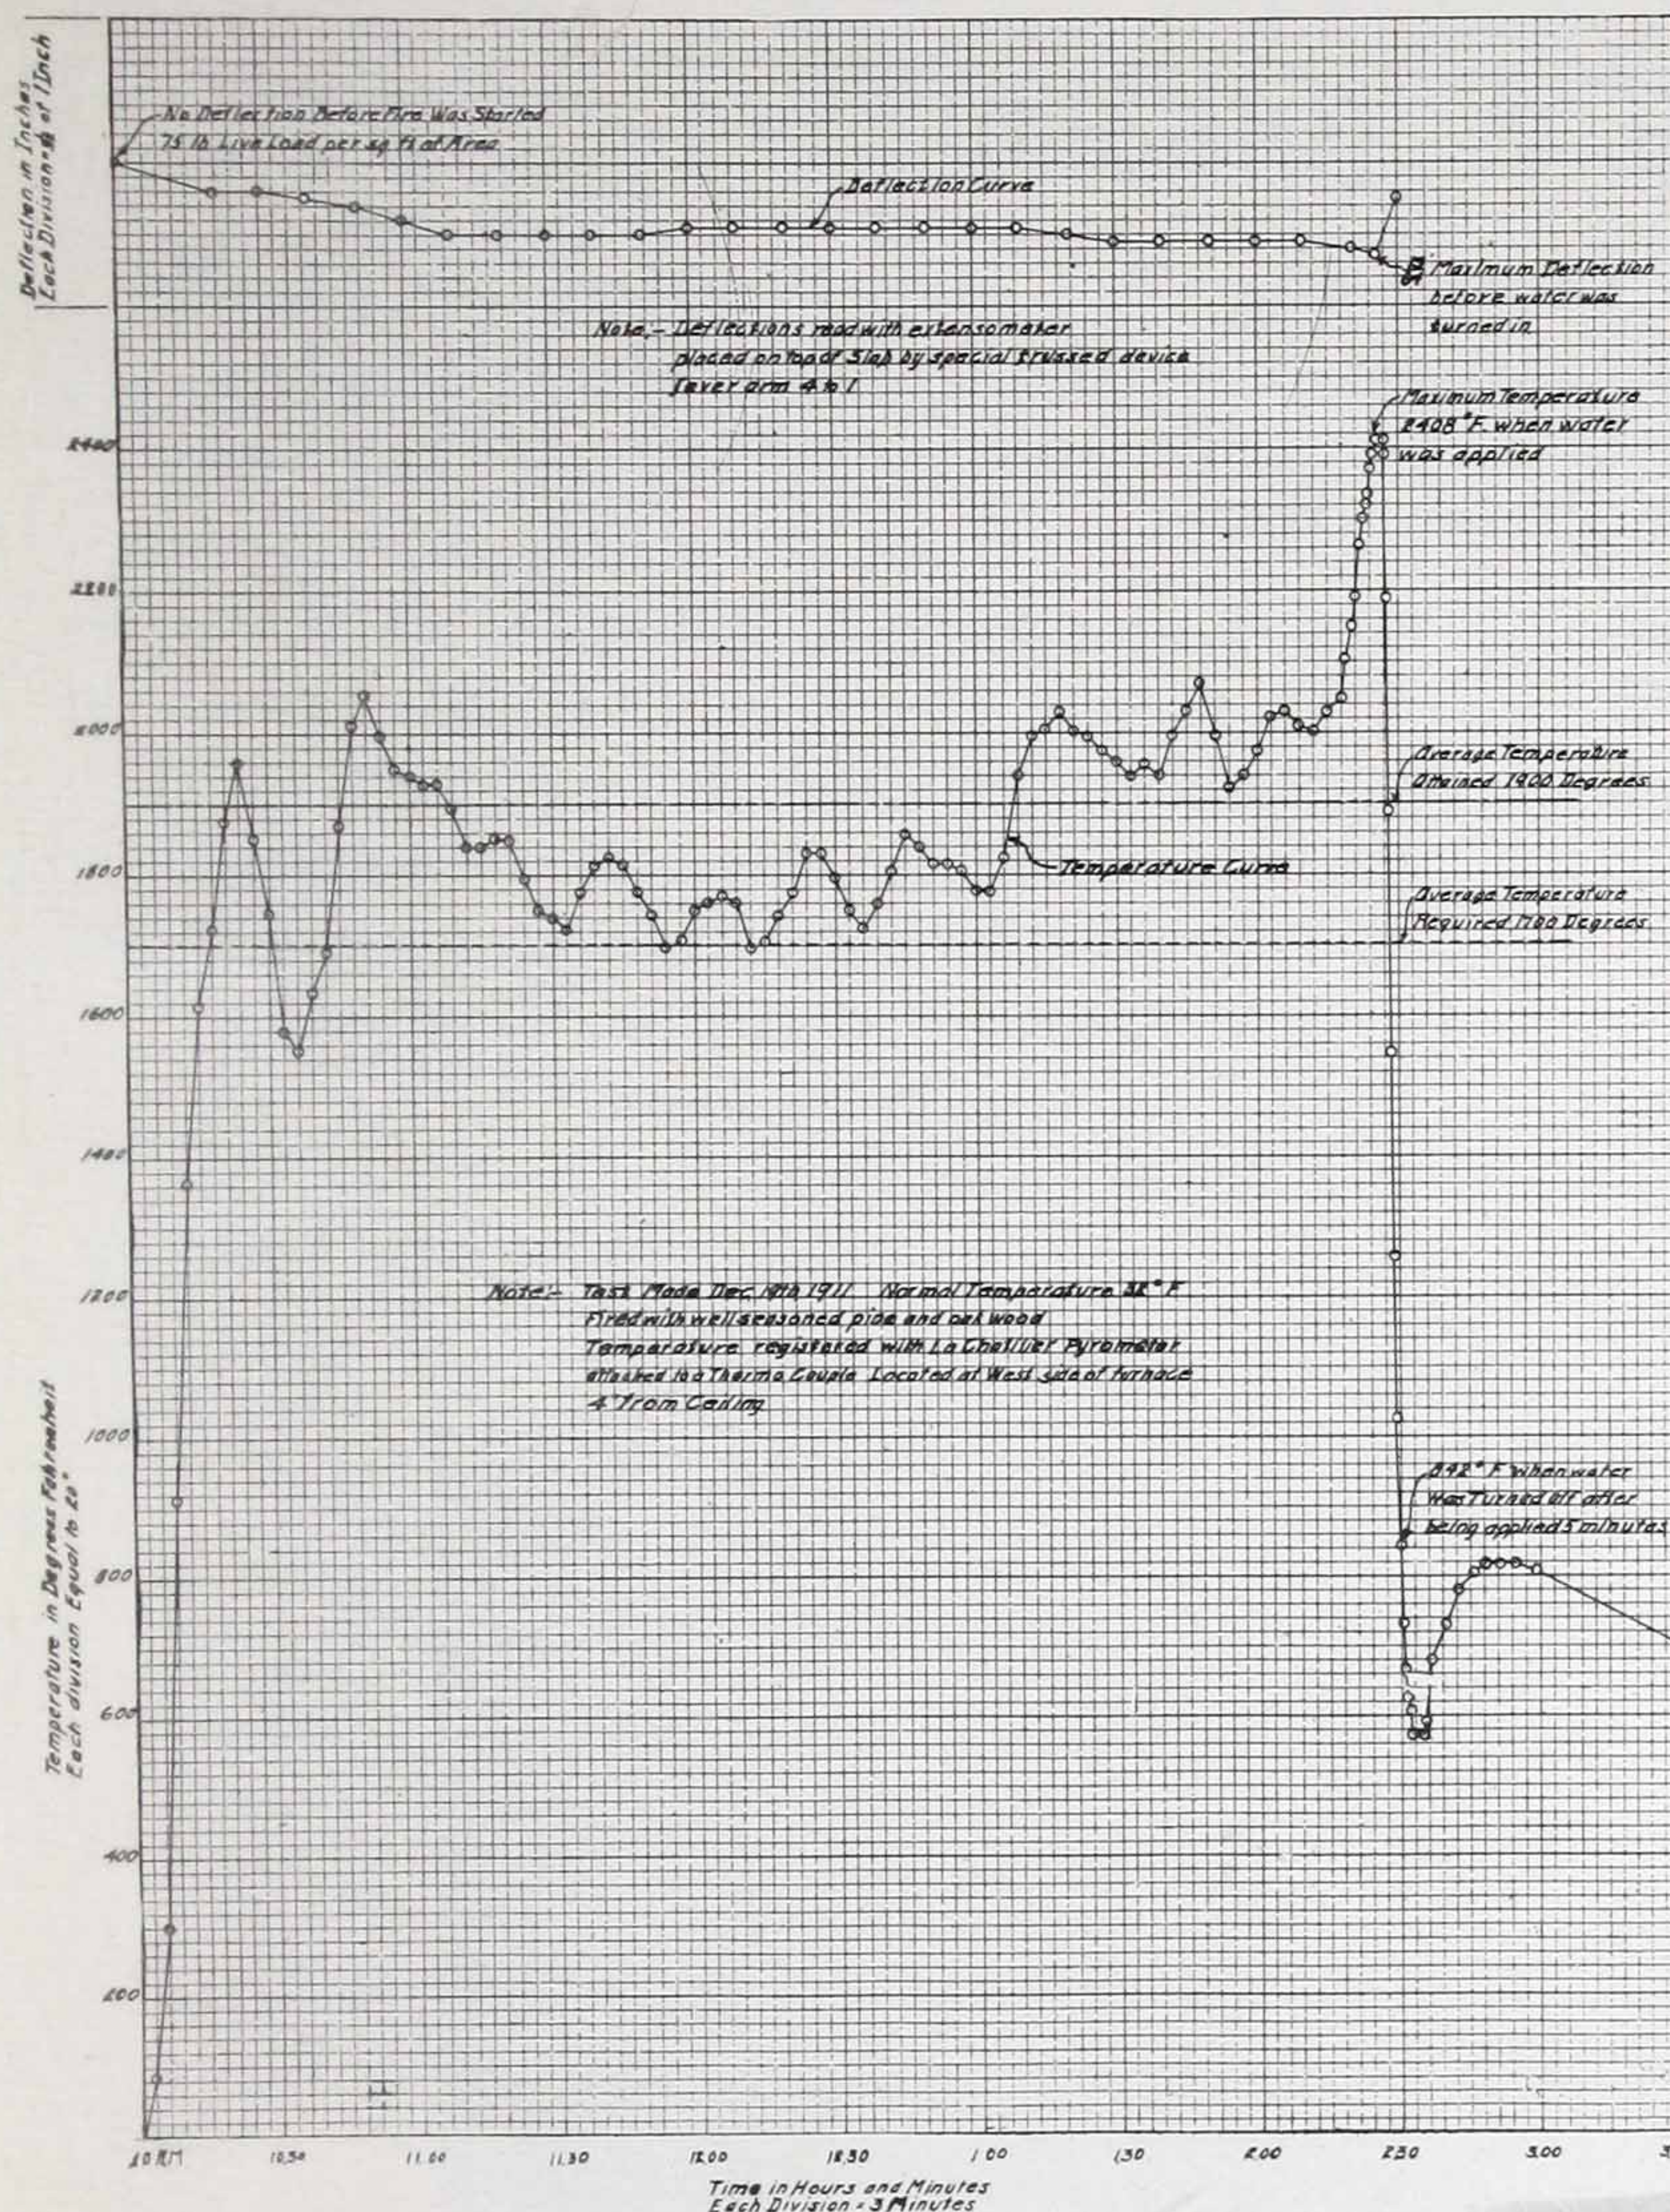
Temperature and Deflection Curves of Fire, Load and Water Test.

It will be noted that the deflection curve is directly proportional to and acts in direct harmony with the temperature curve. When the temperature increased, the deflection increased; when the temperature was stationary, the deflection was stationary; when the temperature decreased, the deflection decreased.

The application of water at the end of four hours reduced the temperature to 842 degrees Fahr., and likewise reduced the deflection to 5/64

of an inch below that which existed before the fire was started.

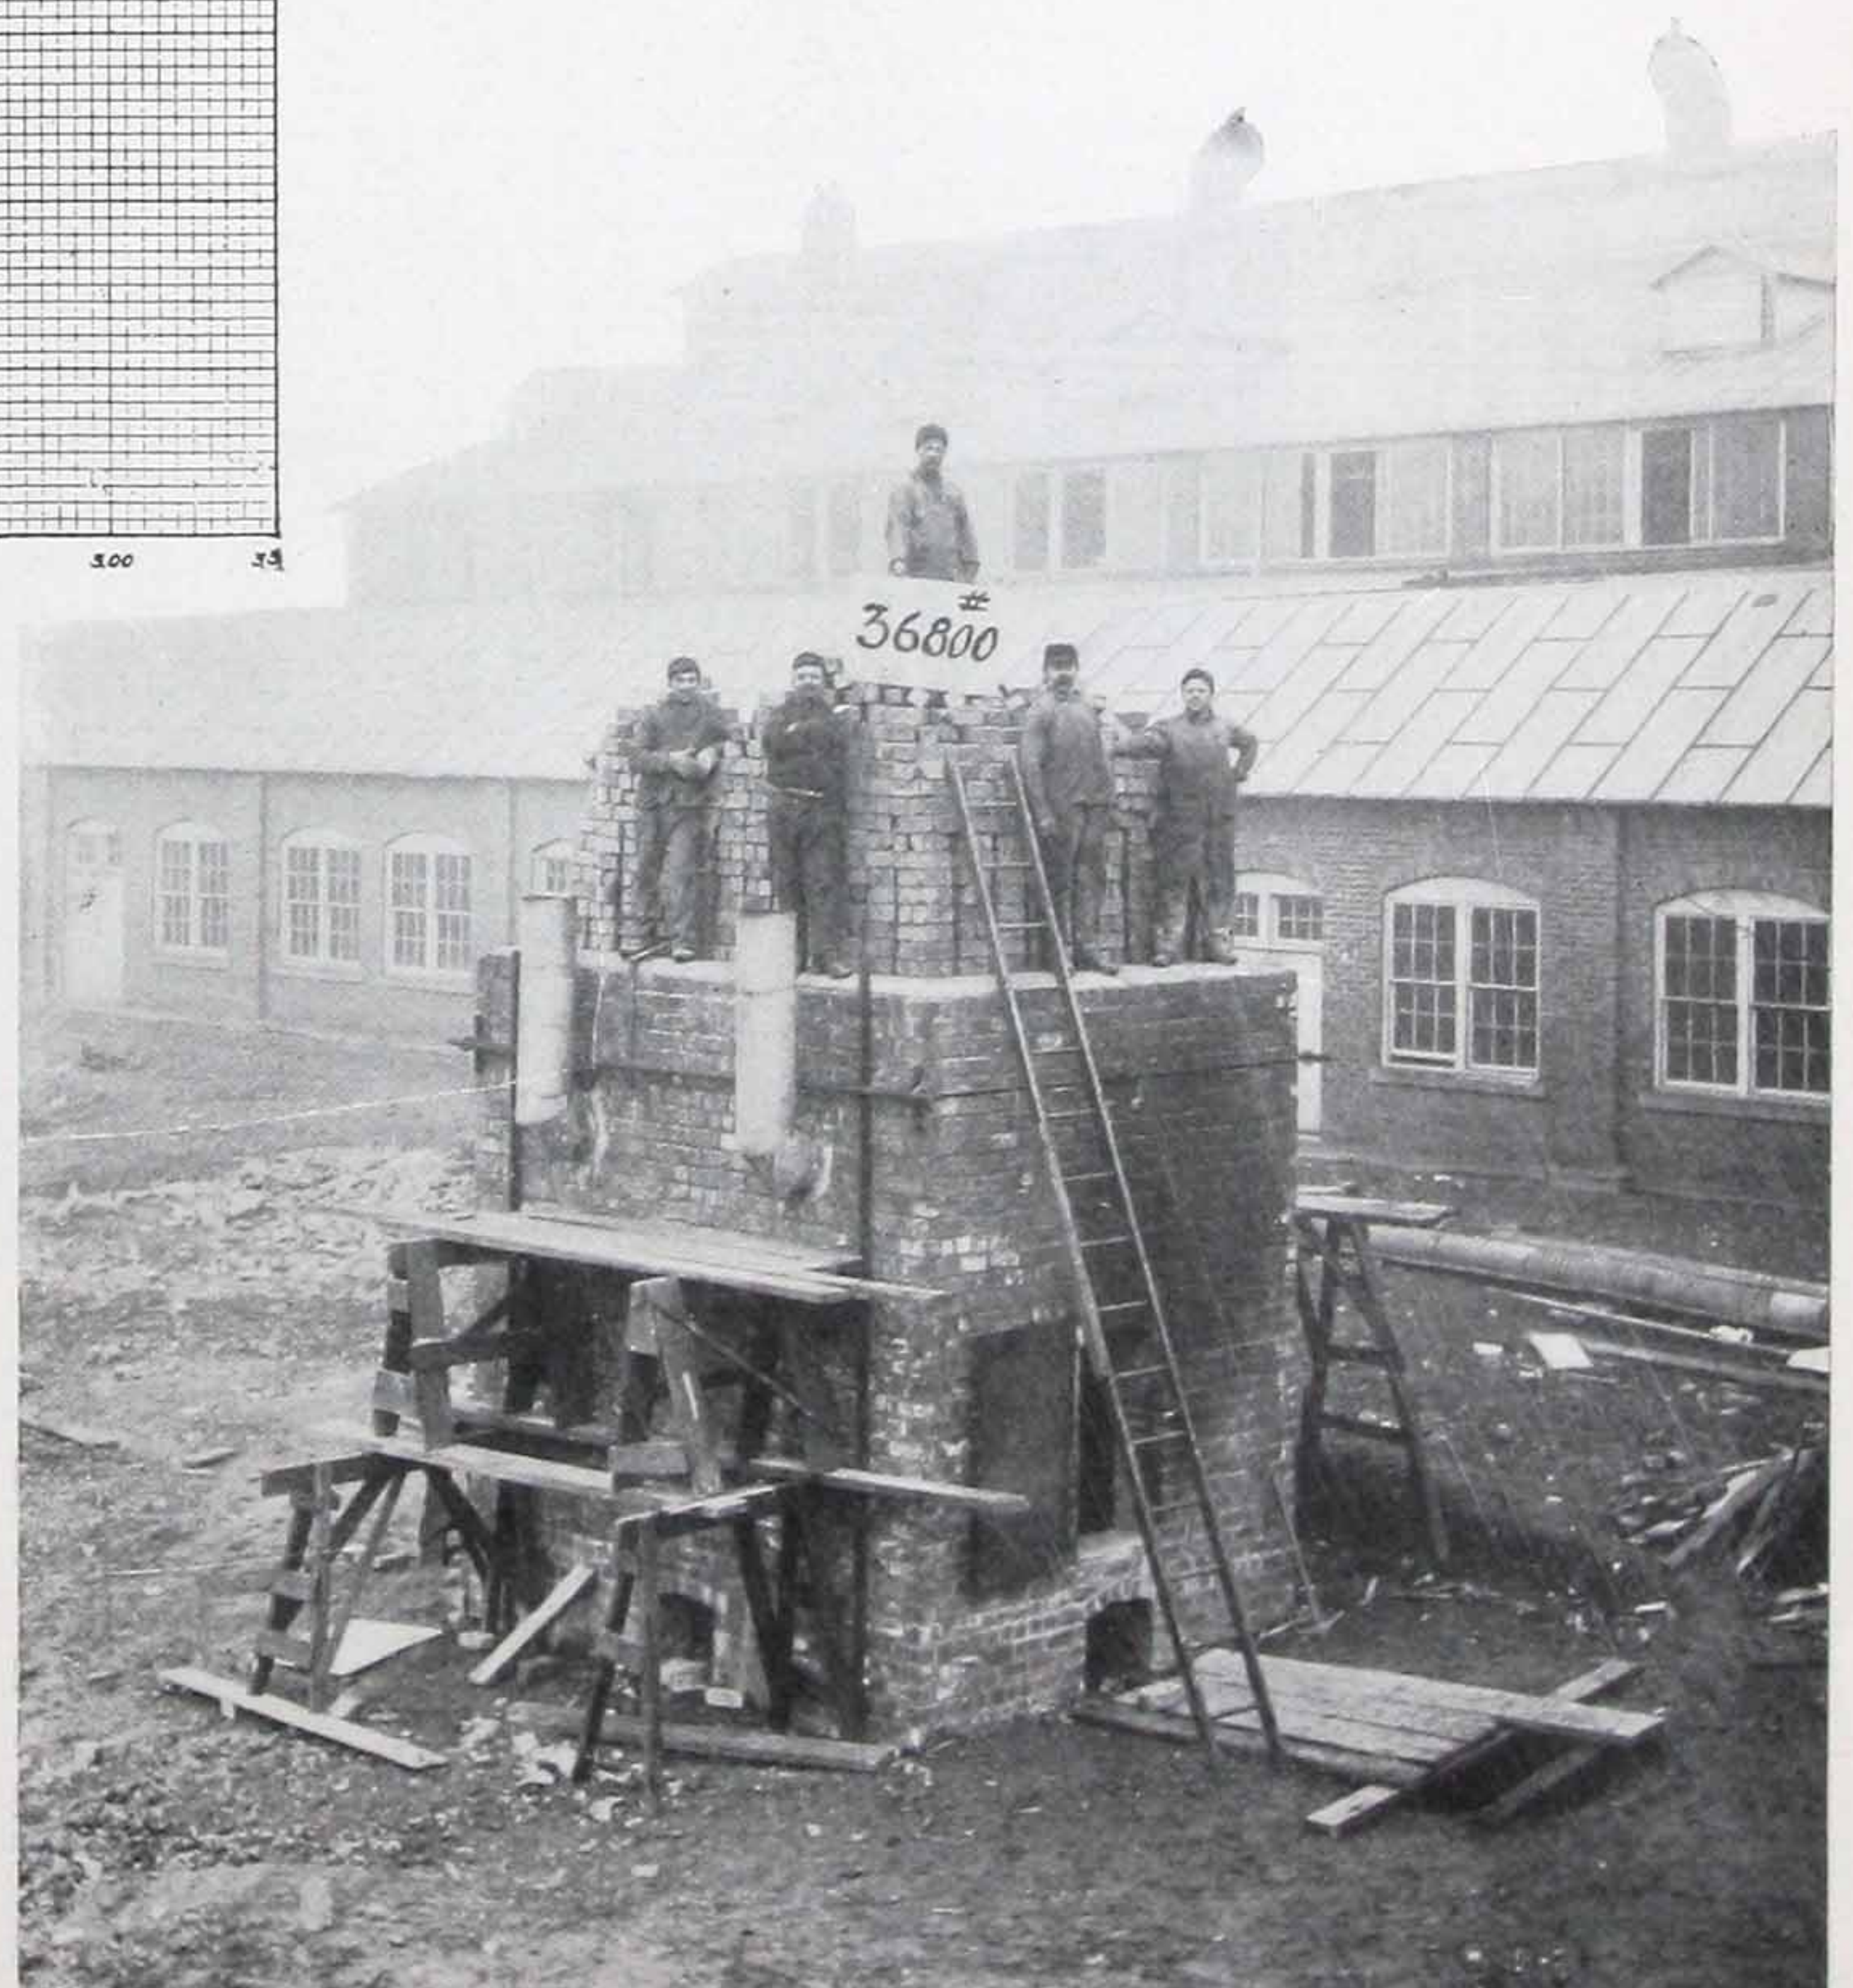
On the following day the slab was loaded to 480 pounds per square foot, or 6.4 times the required live

Fire, Load and Water Test on METAL LUMBER System of Fireproof Floor Construction. Load Test Next Day, 480 Pounds per Square Foot. 9/64-inch Deflection.

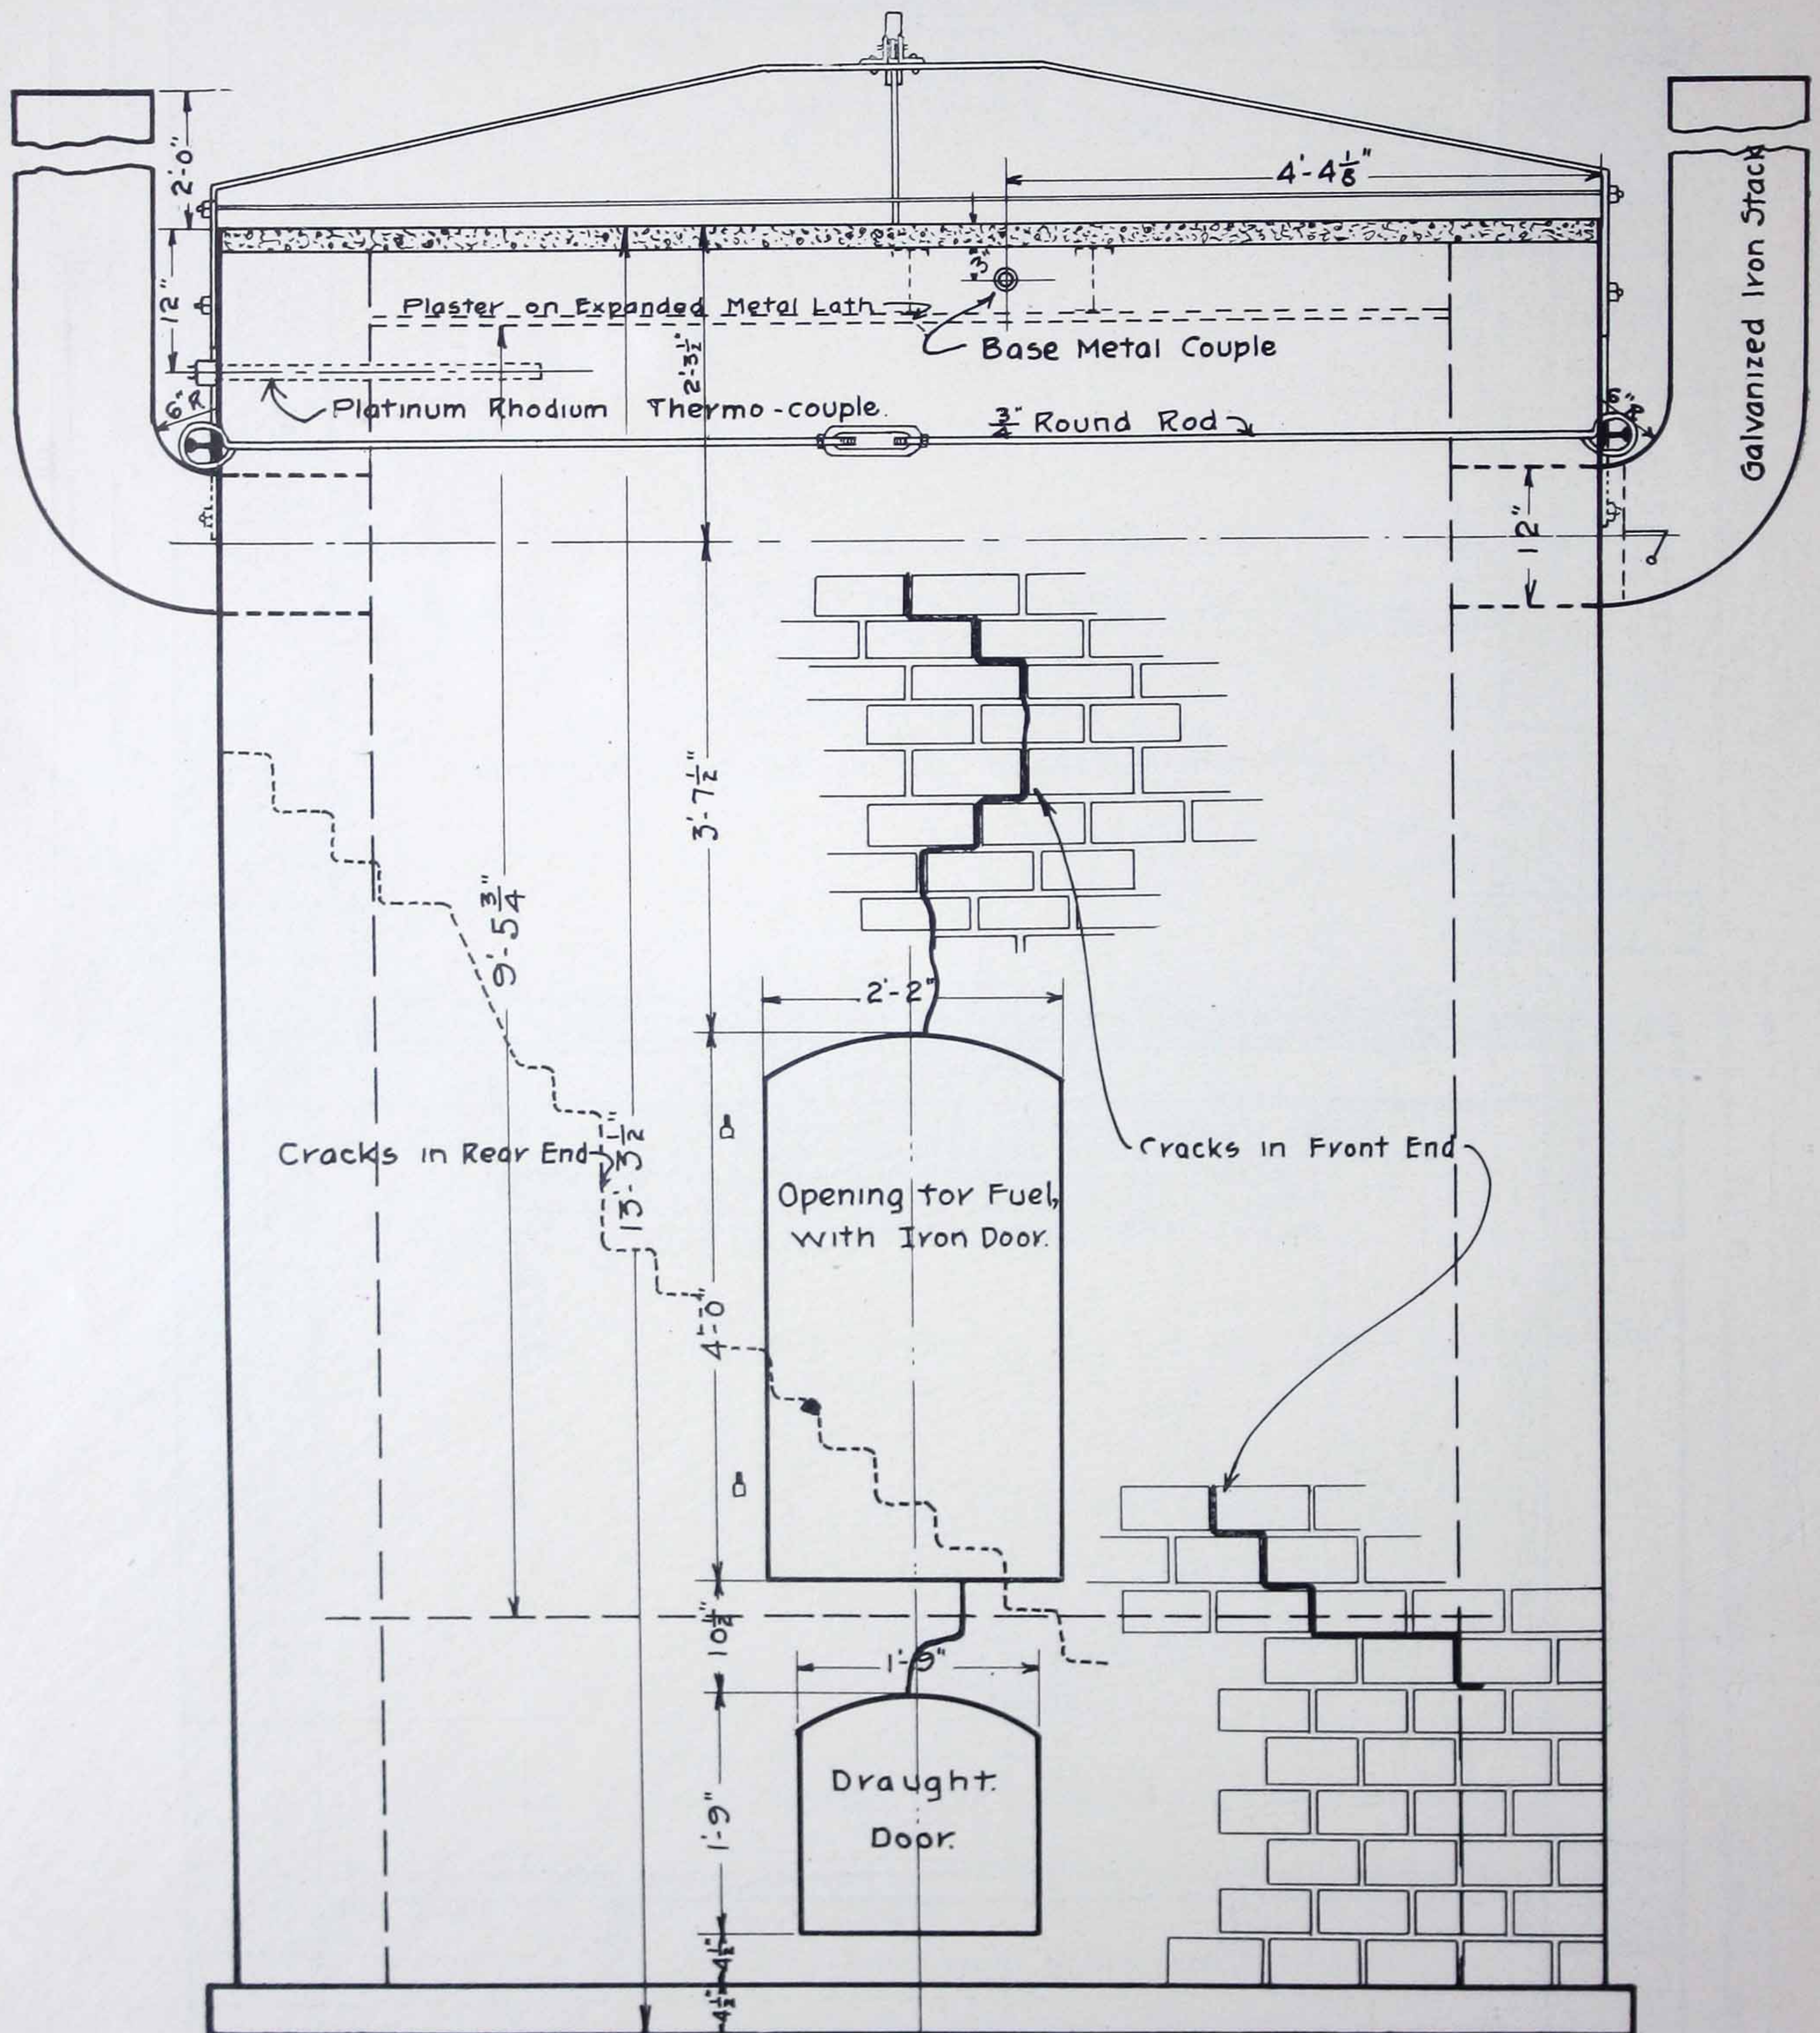
Figure 4—Front Elevation of Furnace Showing Condition of Walls After Test.

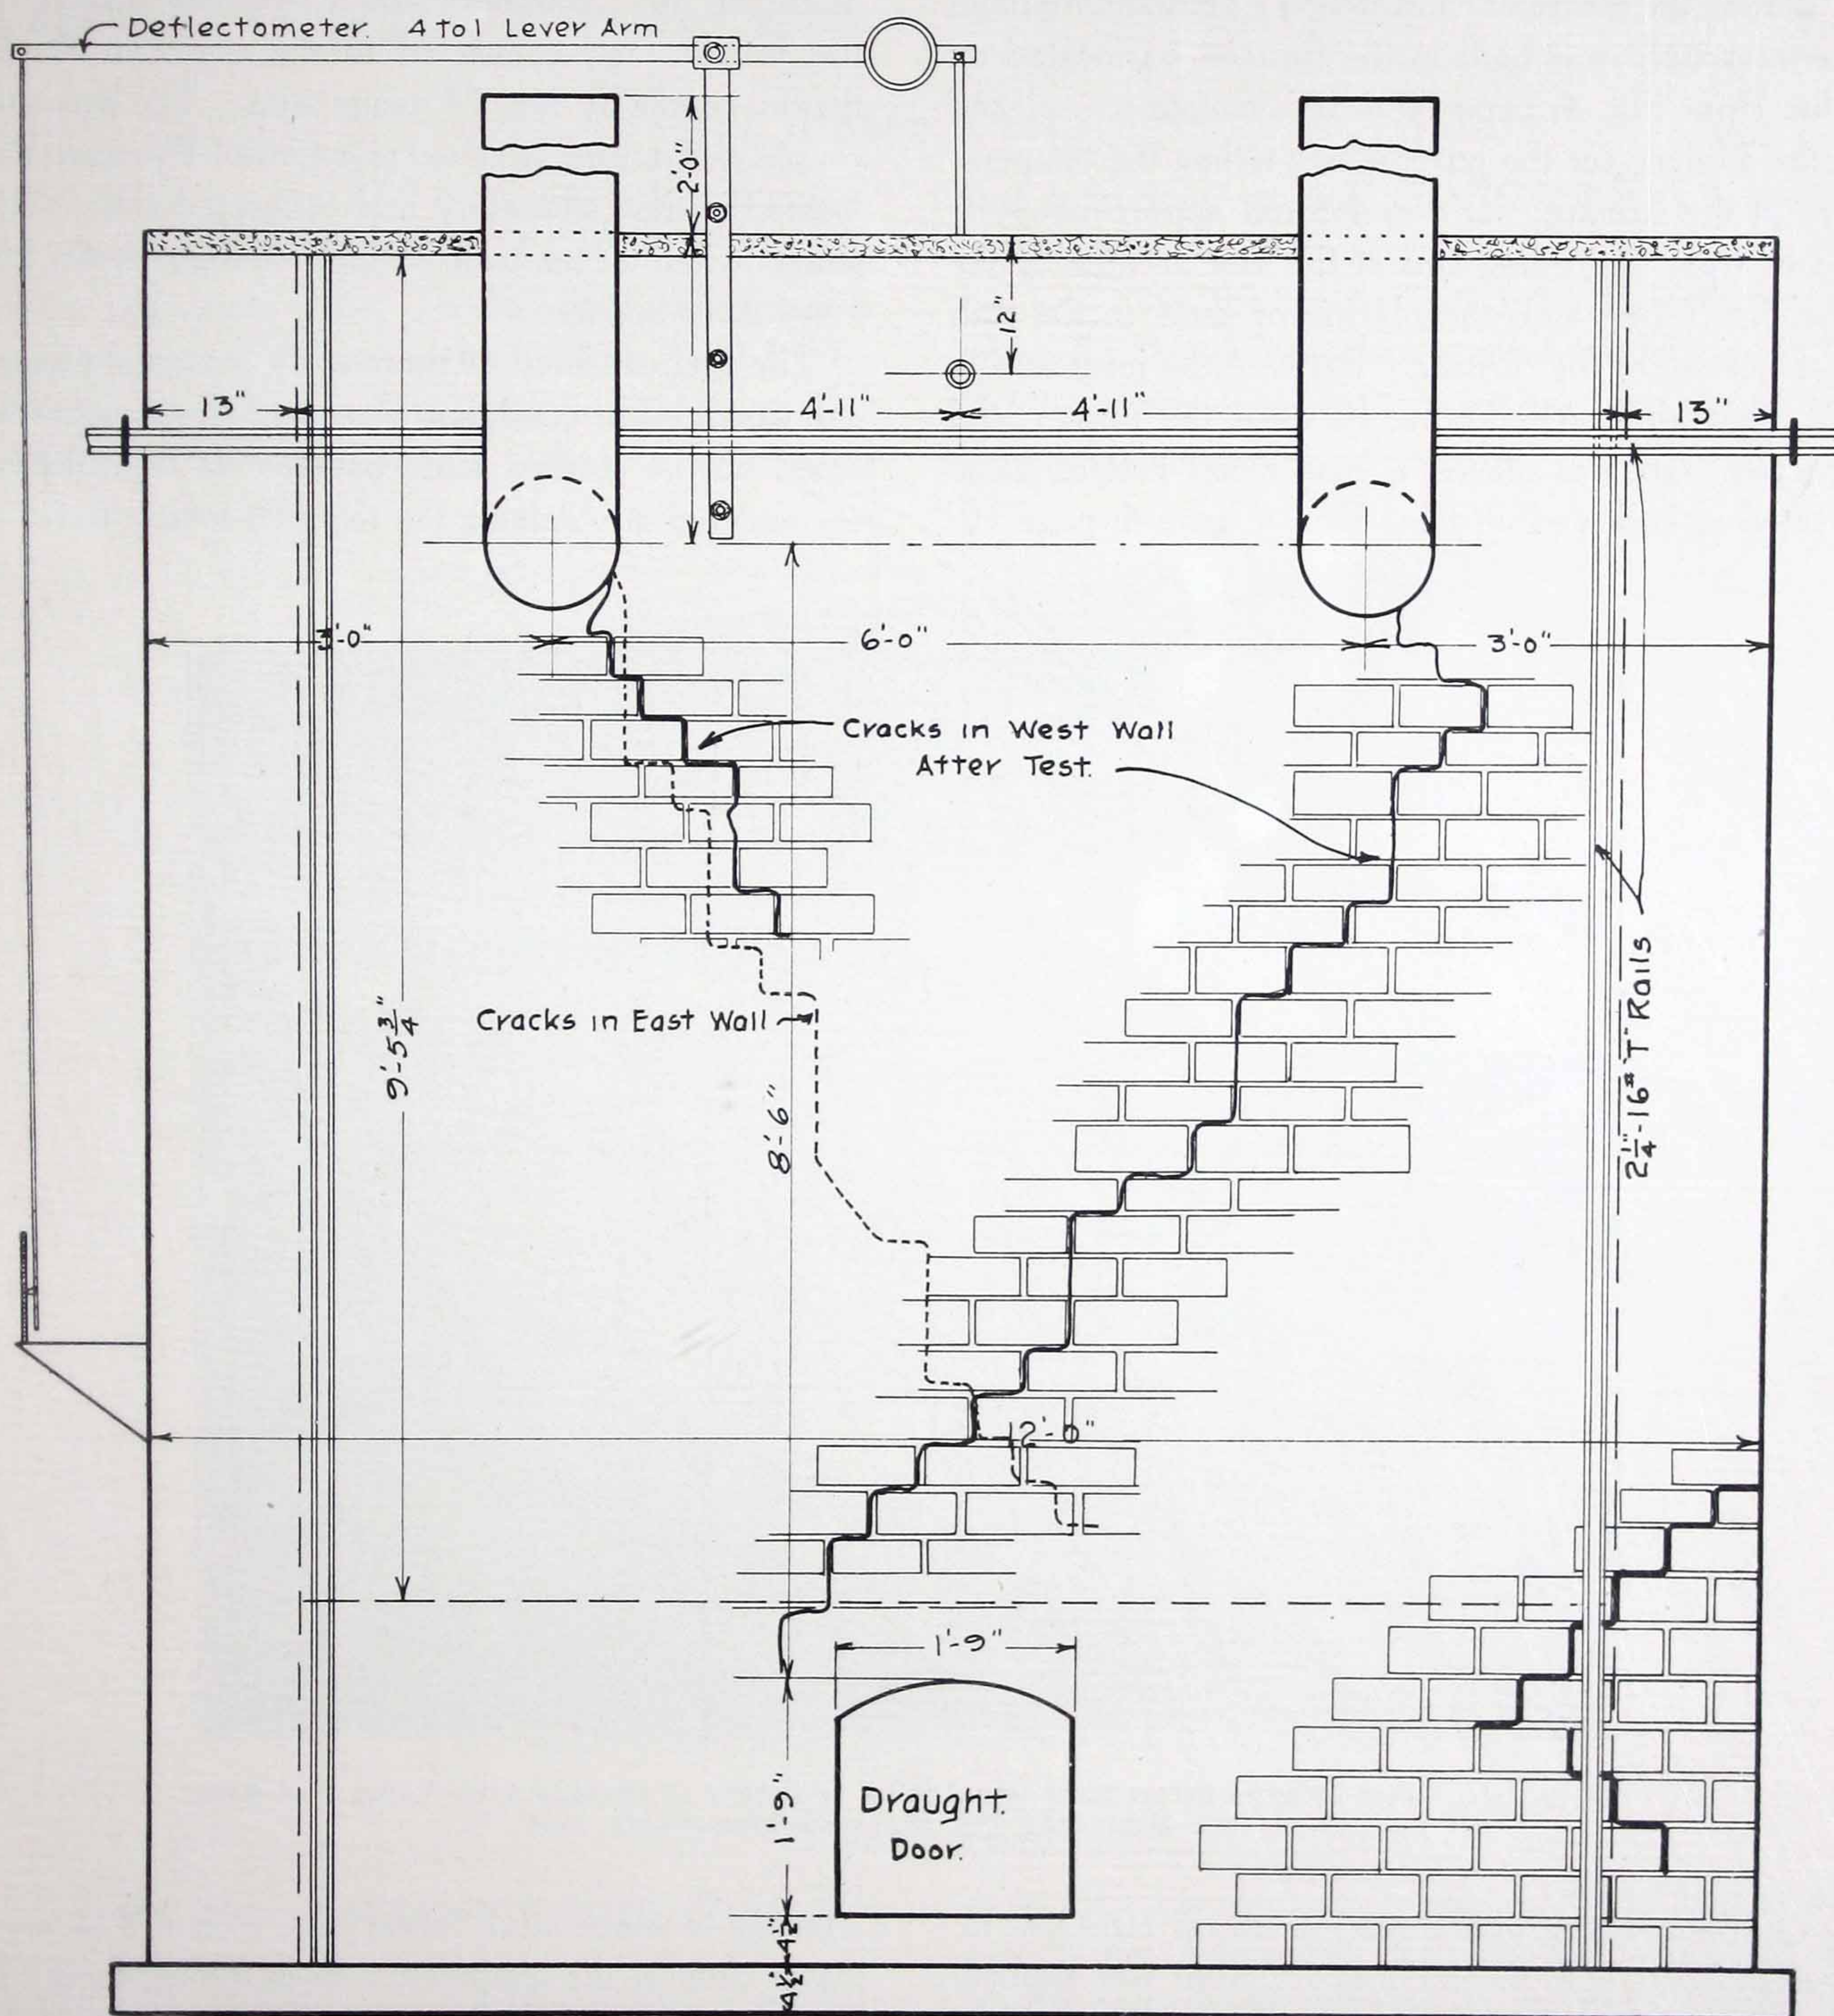
Figure 5—Side Elevation of Furnace Showing Location of Cracks in Walls as Result of Test.

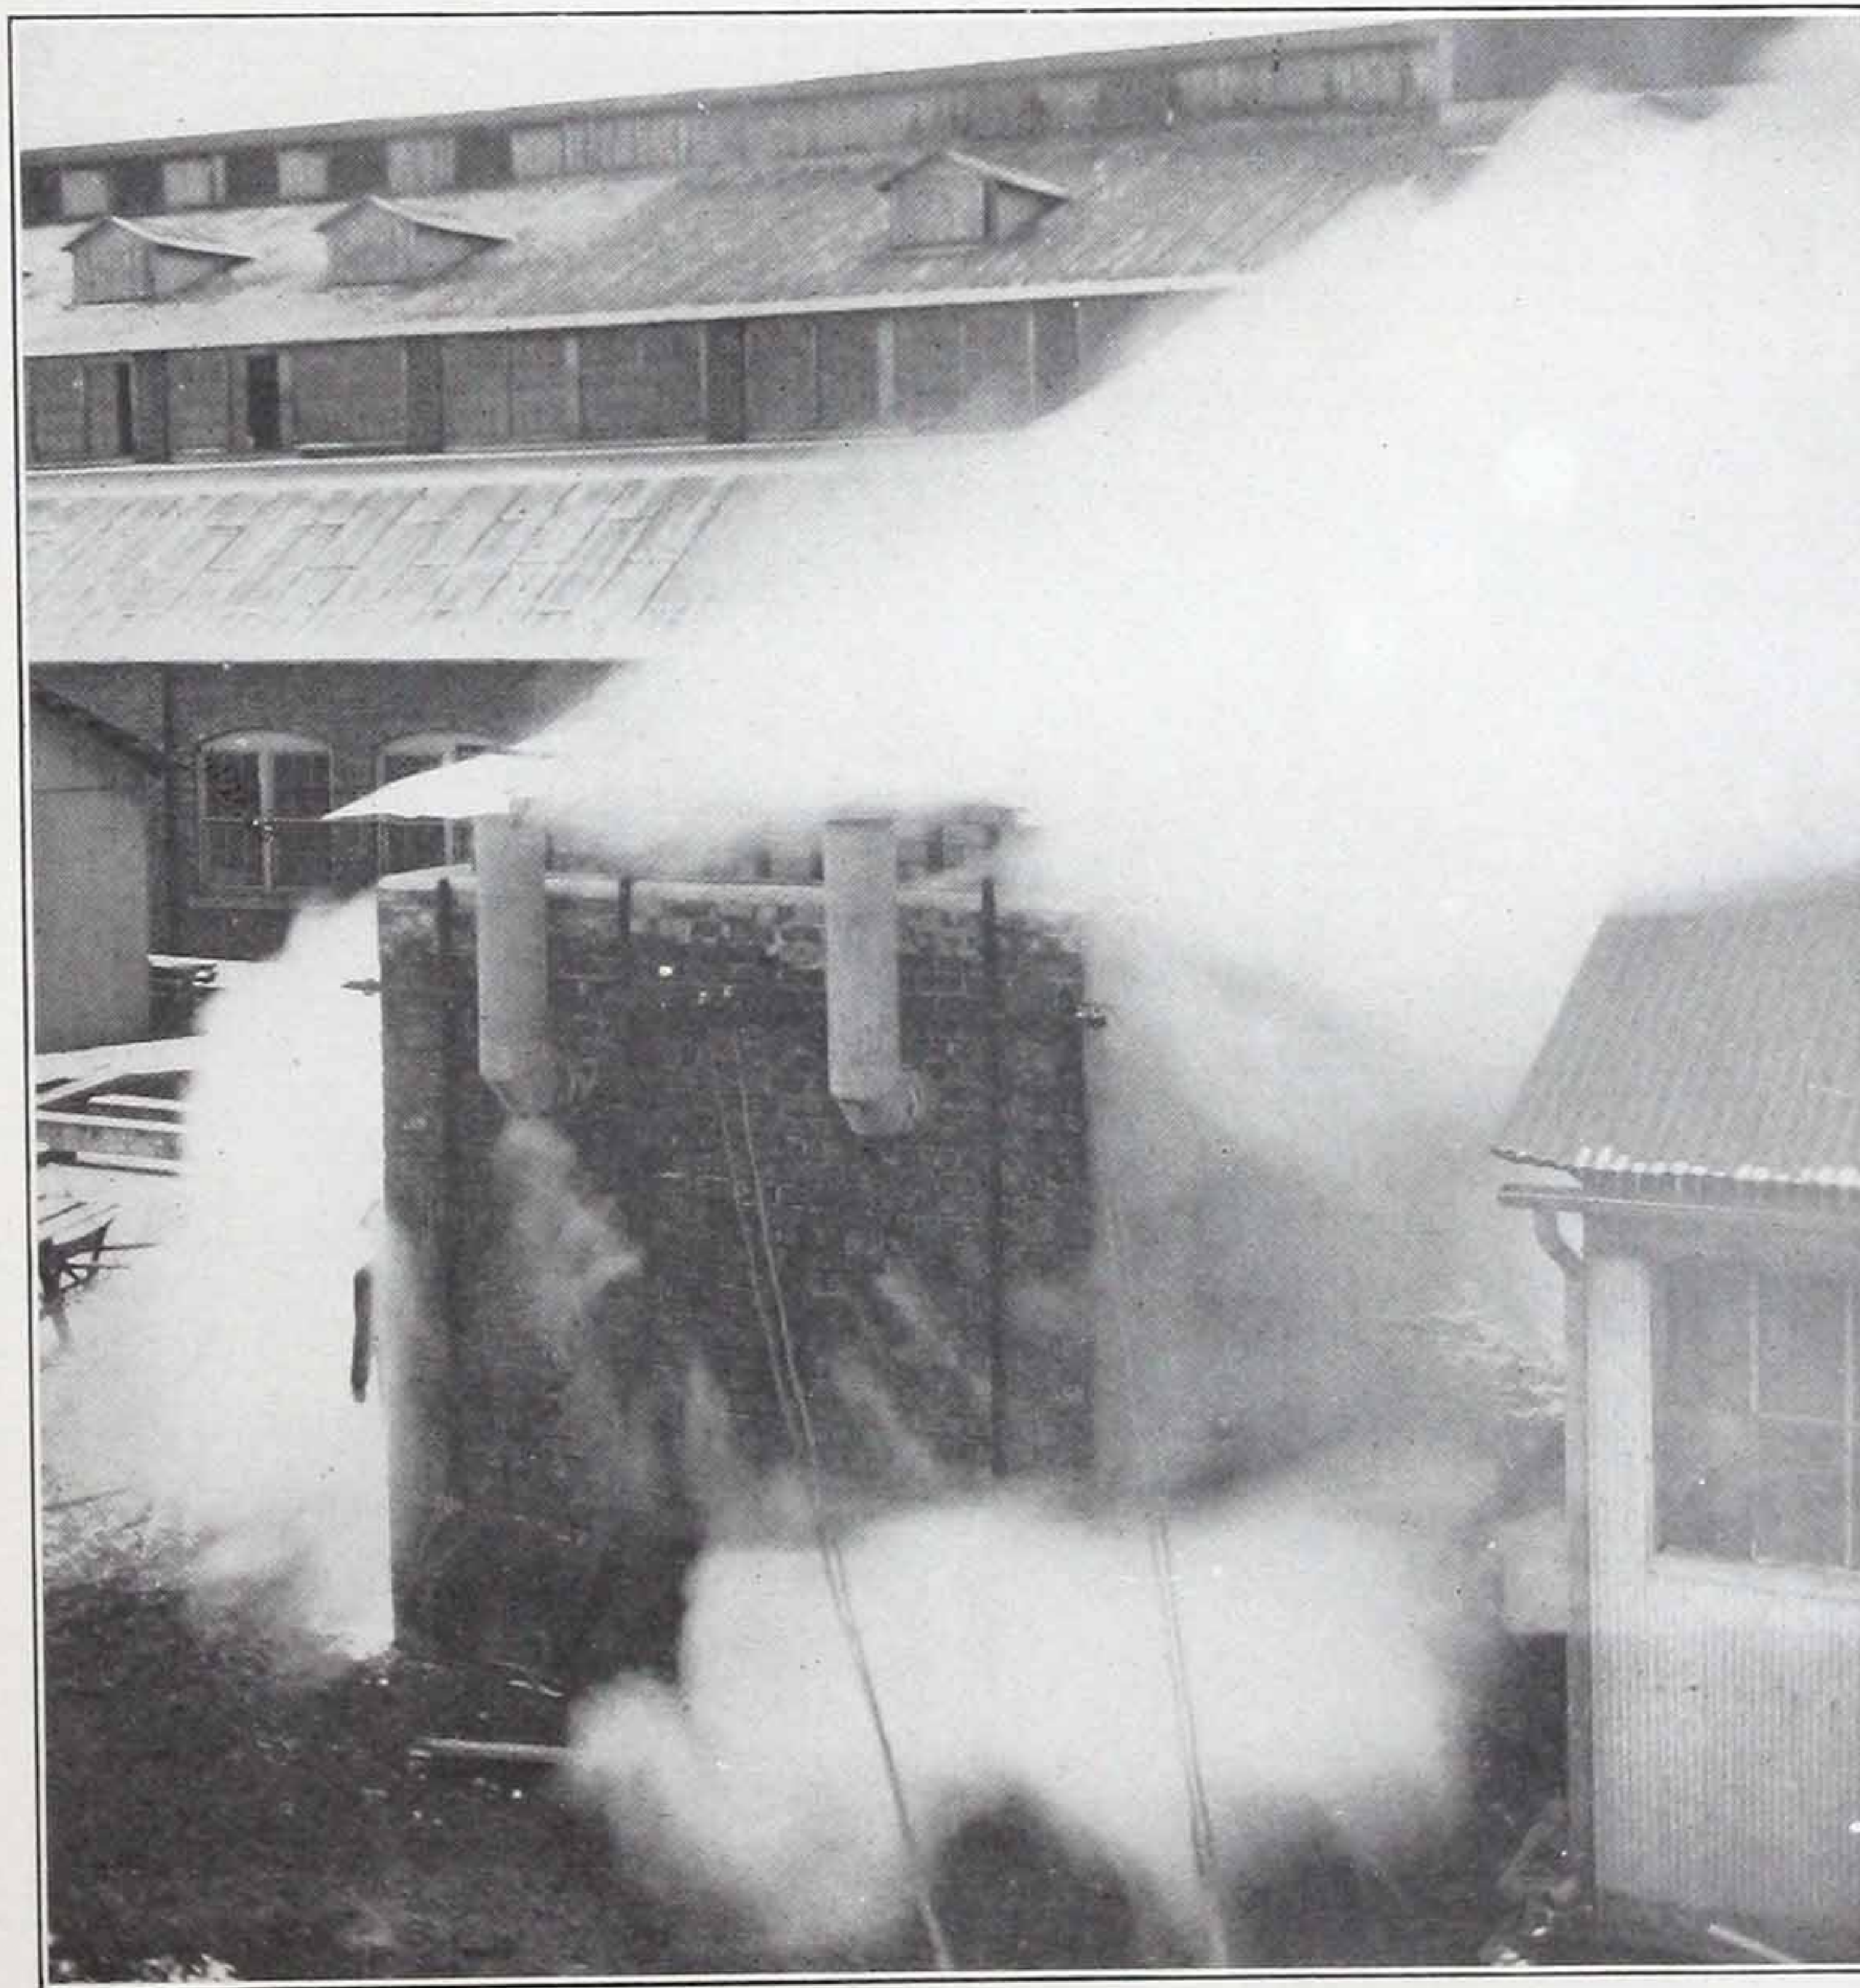
at a distance of not more than 10 feet from the end of the nozzle. Approximately 4 square feet of lath was exposed after the stream had been applied for five minutes. Water was then applied to the top of the slab by means of a small garden hose and the furnace thoroughly cooled.

Water Applied to Furnace Ceiling, Pressure 65 lbs. per Square Inch at Hydrant and Carried by  $2\frac{1}{2}$ -inch Cotton Hose with  $1\frac{1}{8}$ -inch Nozzle.
